May 01, 2006  
FINAL SUBMITTAL

## ADA COMPLIANCE STUDY

Submitted By:  
Heery International, Inc.  
999 Peachtree Street, N.E.  
Atlanta, Georgia 30309-3953  
404-881-9880

In November 2005 Heery International, Inc. was commissioned by Georgia State University (GSU) to provide a survey of 43 buildings and 6 parking decks, for compliance with the Americans with Disabilities Act Accessibility Guidelines (ADAAG). The survey assessed all areas that may be utilized by disabled persons such as restrooms, path of travel in the buildings, doors, elevators and stairs, drinking water fountains, signage, floor surfaces, public telephones, parking and seating in major assembly areas.

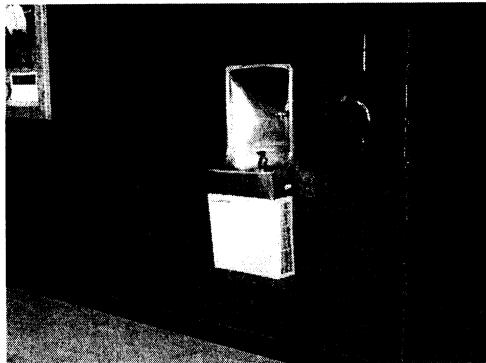
*Drinking Fountain 1*

Non-compliant knee space clearance, height of spout & twist faucet handle

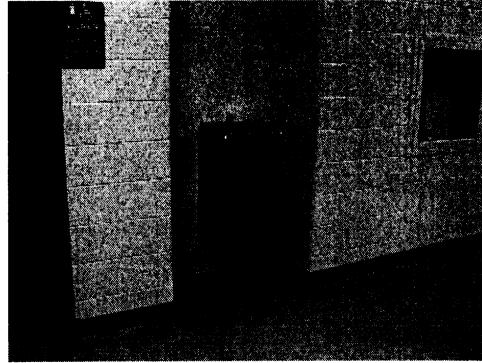
*Drinking Fountain 2*

Non-compliant knee space clearance, height of spout & twist faucet handle

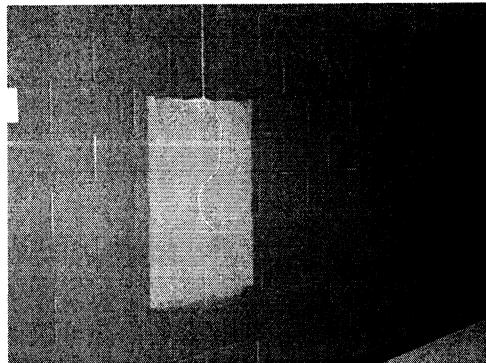
*Public Telephones*

Removed leaving no compliant telephones in the building

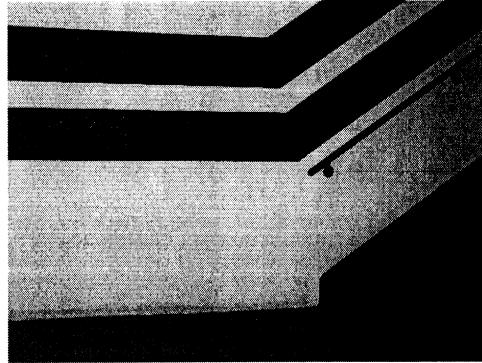
*Interior Handrail 1*

Missing 12" horizontal extension to handrail

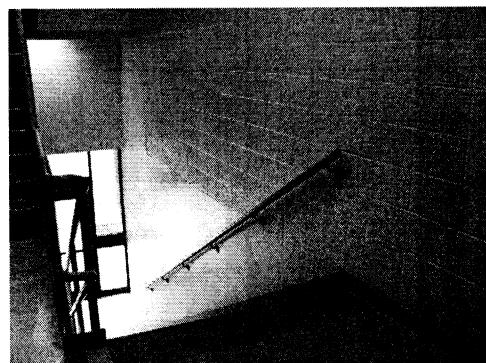
*Interior Handrail 1*

Missing 12" horizontal extension to handrail at top and bottom landings

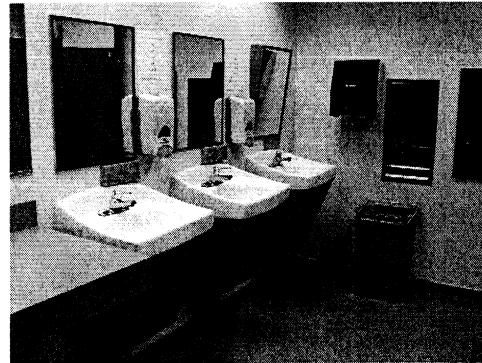
*Lavatories & Accessories 1*

Non-compliant knee space clearance, towel dispenser too high, soap dispenser out of reach

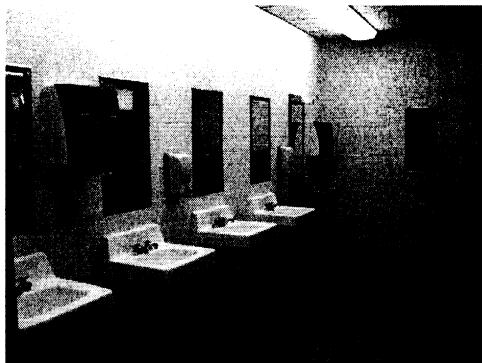
*Lavatories & Accessories 1*

Non-compliant insulation wrap at lavatory piping, faucet handles, height of paper towel dispenser and height of lavatory

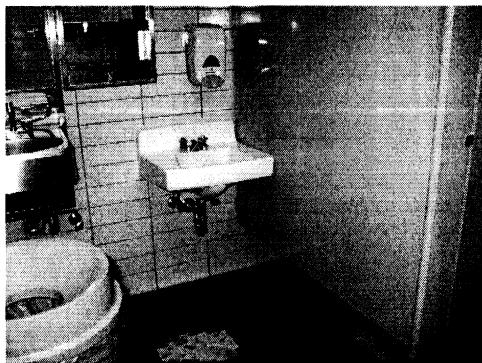
*Lavatory Insulation*

Non-compliant lavatory insulation wrap on piping, faucet handles and lavatory side clearances

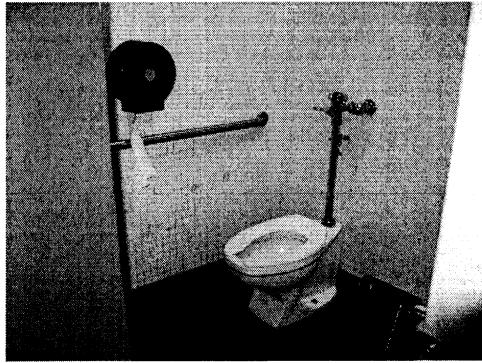
*Dispenser Location & Grab Bars*

Non-compliant toilet paper dispenser and missing back grab bar

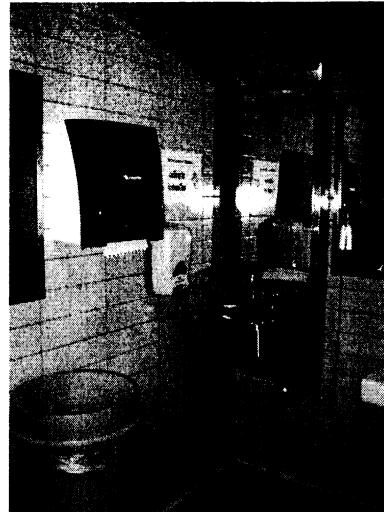
*Lavatories & Accessories 3*

Non-compliant height of lavatory, height of towel dispenser and lavatory side clearance

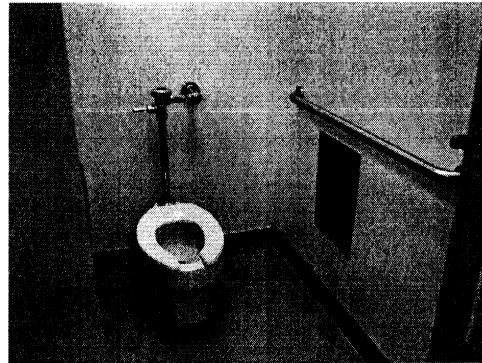
*Toilet Location and Grab Bars*

Toilet too far from wall and missing back grab bar

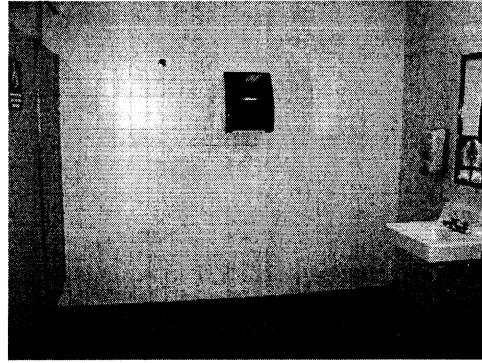
*Dispenser Type & Location*

Non-compliant dispenser type (two hands required) and mounted too high

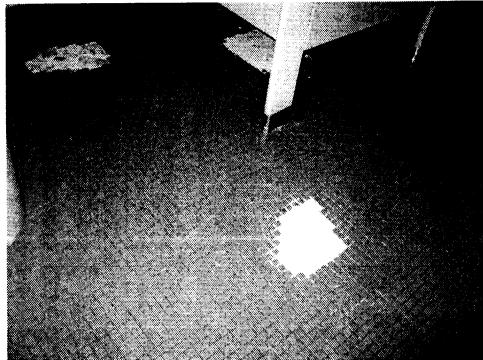
*Flooring Hazards*  
Rough or hazard floor condition

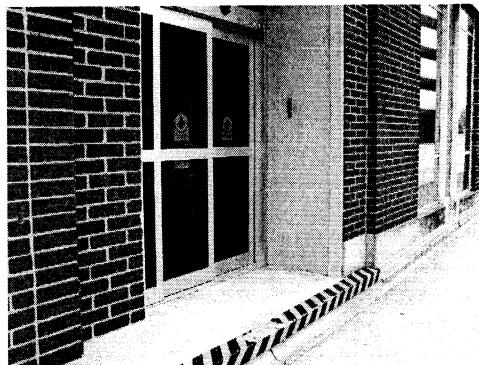
*Building Access*  
Non-compliant access – missing ramp

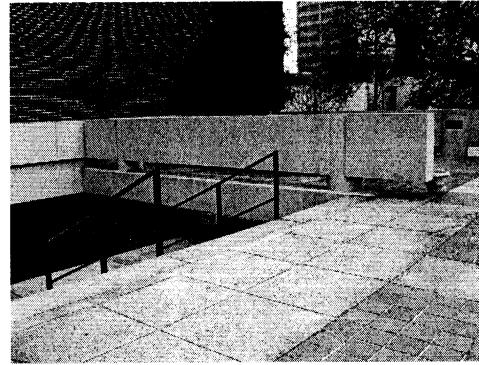
*Exterior Handrail*  
Handrail is missing 12" horizontal extension

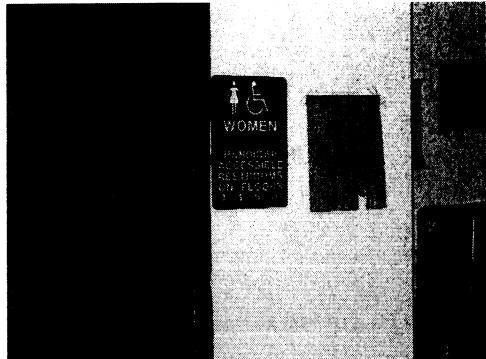
*Signage Type*  
Braille is missing

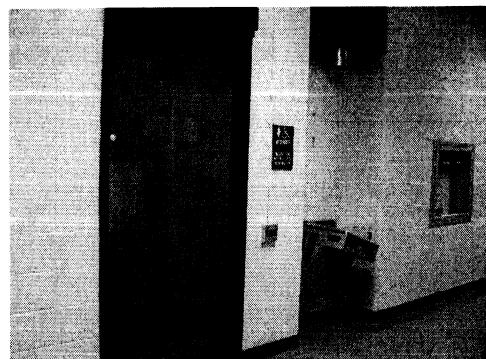
*Signage Type & Location*  
Signage mounted on wrong side of door and  
missing Braille

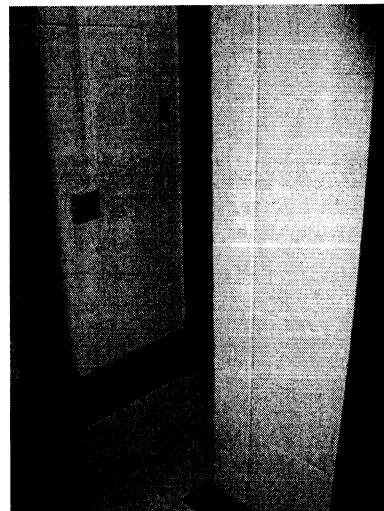
*Access Corridors*  
Corridor turning radius too narrow

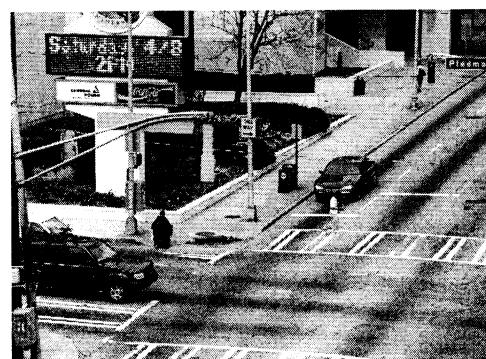
*Curb Cuts and Site Access 1*  
Missing well defined edges at curb

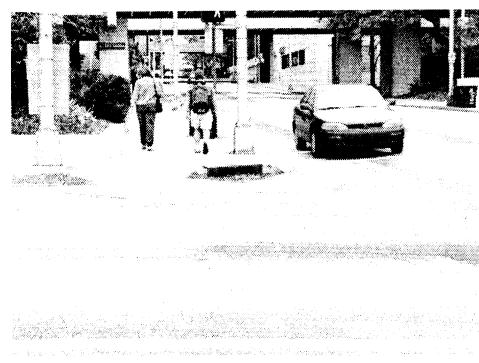
*Curb Cuts and Site Access 2*  
Slope of flared side is too steep

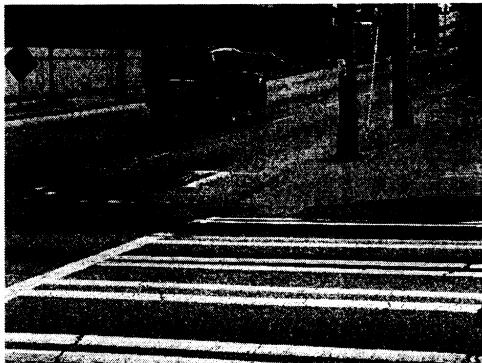
*Curb Cuts and Site Access 3*

Distance from end of ramp into path of vehicular traffic doesn't meet the minimum requirements
